National Register of Historic Places Registration Form

historic name Cragun, Strange Nathaniel, House

street & number 404 West Main Street

city or town Lebanon

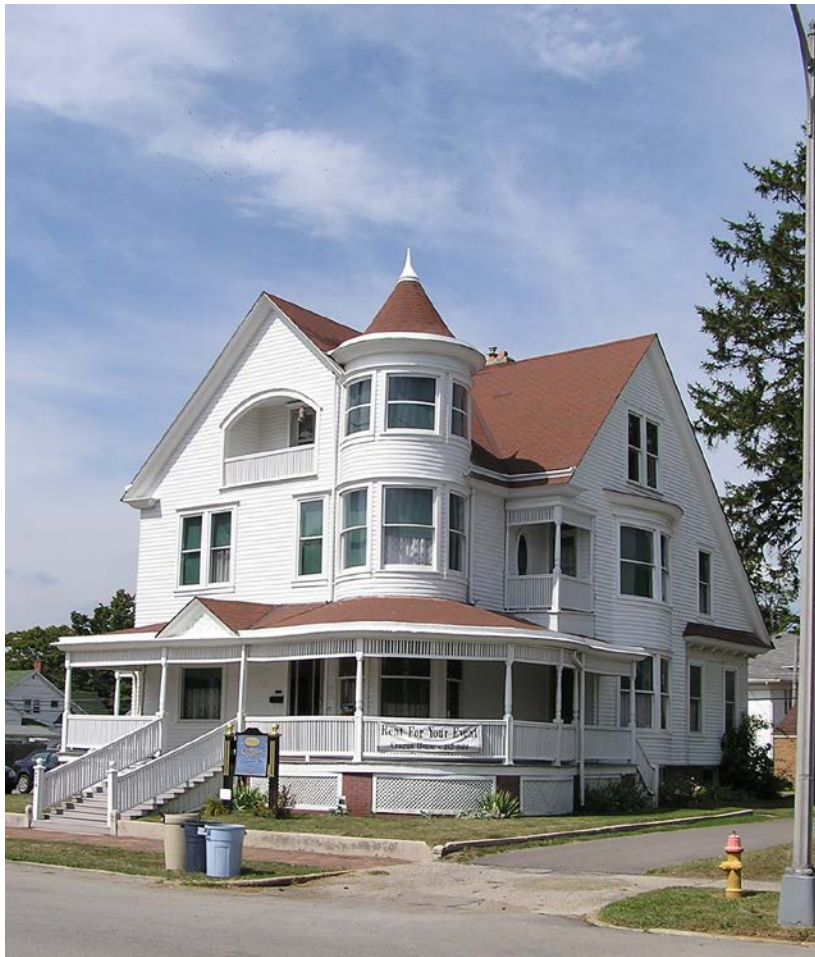
Cragun House, Boone County, IN photo 1

Photo 1 looking NW at main (south) façade & east elevation

The main south façade of the S. N. Cragun House (photo 1) rises two-and-a-half stories over a slightly raised basement of brick with awning-type one-light windows. The original wood frame windows in the house proper are consistently one-over-one doublehung sashes. The original clapboard siding is intact. A wooden porch with a balustrade, balustrade frieze and eight turned posts extends across the entire width of the front gabled portion and around part of the east elevation. Wide steps with banisters lead onto the porch to the oversized main entrance door featuring a beveled glass window. Above the entrance to the porch is a gabled pediment with arabesque bas-relief. At the southeast corner above the porch rises a two-story tower topped with a conical roof. Behind—just north of the tower on the second floor—is an open balcony with a balustrade, a full turned post at the outer corner and two turned half-posts where the balcony meets the walls of the house. Access to the balcony from within is by a single door facing south; there is an oval window with stained glass facing east onto the balcony. Beneath this balcony is a side door facing south, opening onto the east side of the porch. The front (south) gable has a return on the west (none on the east because of the tower) at the top of the second story. Inset into the gable on the third story is a balcony within a segmental arched opening with a balustrade across the front. The part of the south façade west of the gable (see photo 2) contains one bay; on the first floor is a door facing south leading onto a side porch with a hipped roof supported by two turned posts and featuring a balustrade and a balustrade frieze that match those on the main porch.

The east elevation (see photo 1) features a curved projecting bay on the lower two stories. Similar to the west elevation, the gable end on the south has a return at the top of the second story; the north gable end is elongated, effectively a saltbox, and intersects with a small shed roof supported by brackets over the two northernmost windows.

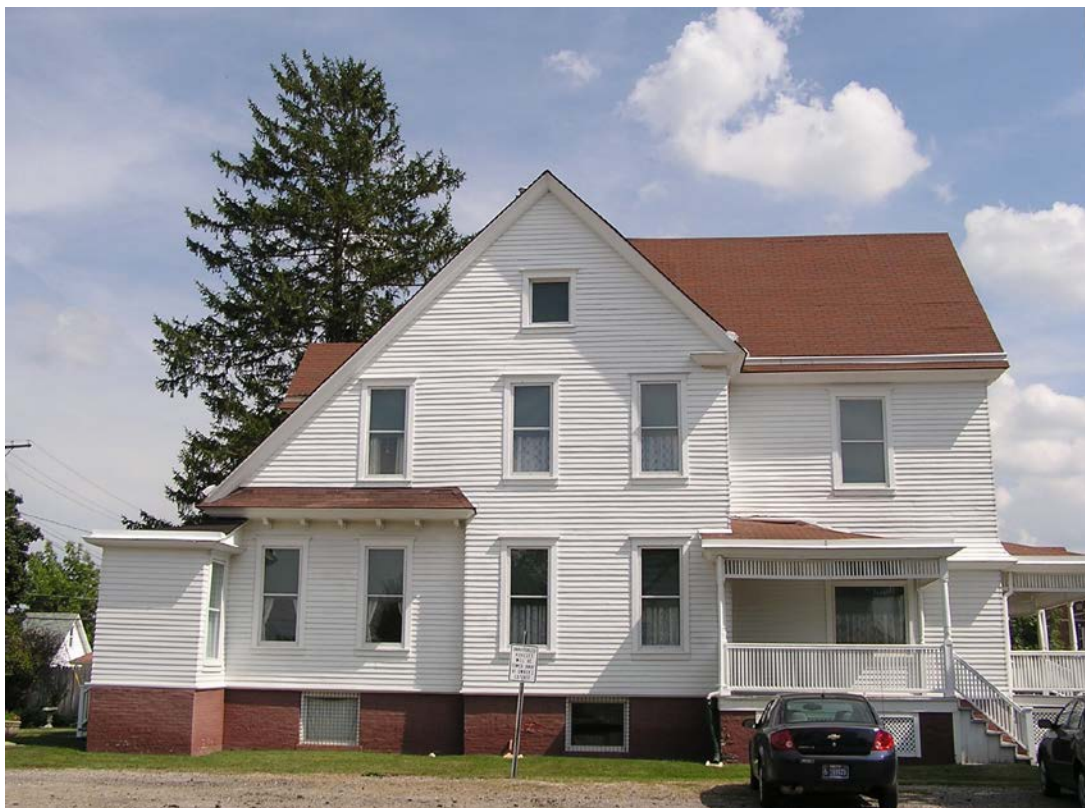
Cragun House, Boone County, IN photo 2

Photo 2 looking ENE at west elevation

The west elevation (photo 2), five bays, displays the above-mentioned side porch. The saltbox-shaped gable has a cornice return at the top of the second story, but its north end intersects a small shed roof supported by brackets over the two northernmost windows (see photo 3). A small square addition (photo 3) extends off the northwest corner of the house; it has but one window, located in its south wall.

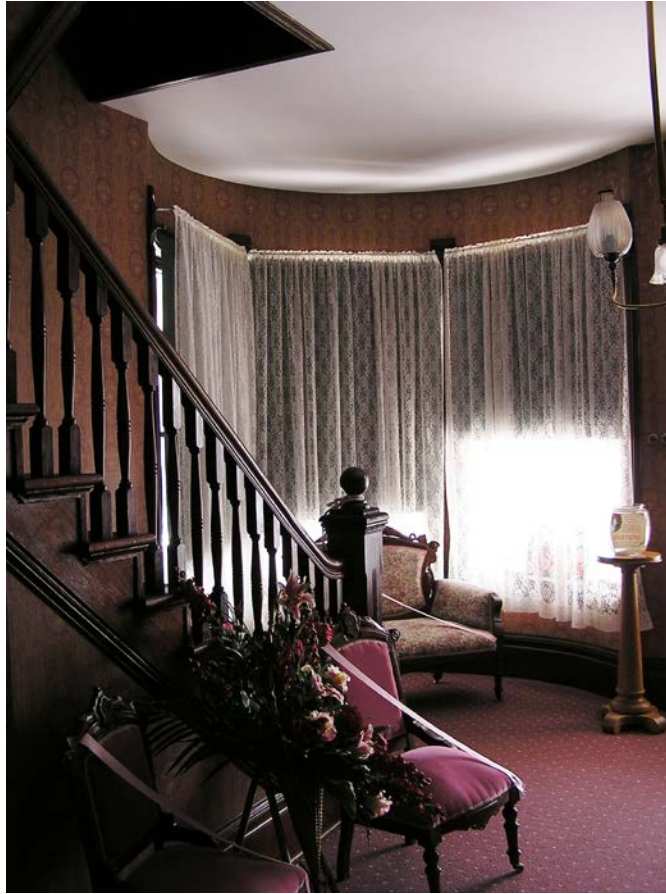
Cragun House, Boone County, IN photo 6

Photo 6 interior, looking SE into reception room

One enters the house through a large paneled door on the south into a small reception hall (photos 5,6) with a winding staircase on the right (east), double pocket doors into the front parlor on the west, and straight ahead, on the north, a doorway into the library (photo 7). The entrance door window contains beveled glass. The southeast corner of this space contains a curved bay (the bottom of the tower) with three one-over-one doublehung sash windows. The stairs, with turned balusters and plain balls on pedestal bases topping the newel posts, rise northward from here and turn west. As noted earlier, the stairwell boasts a stained glass oval window at the second floor level.

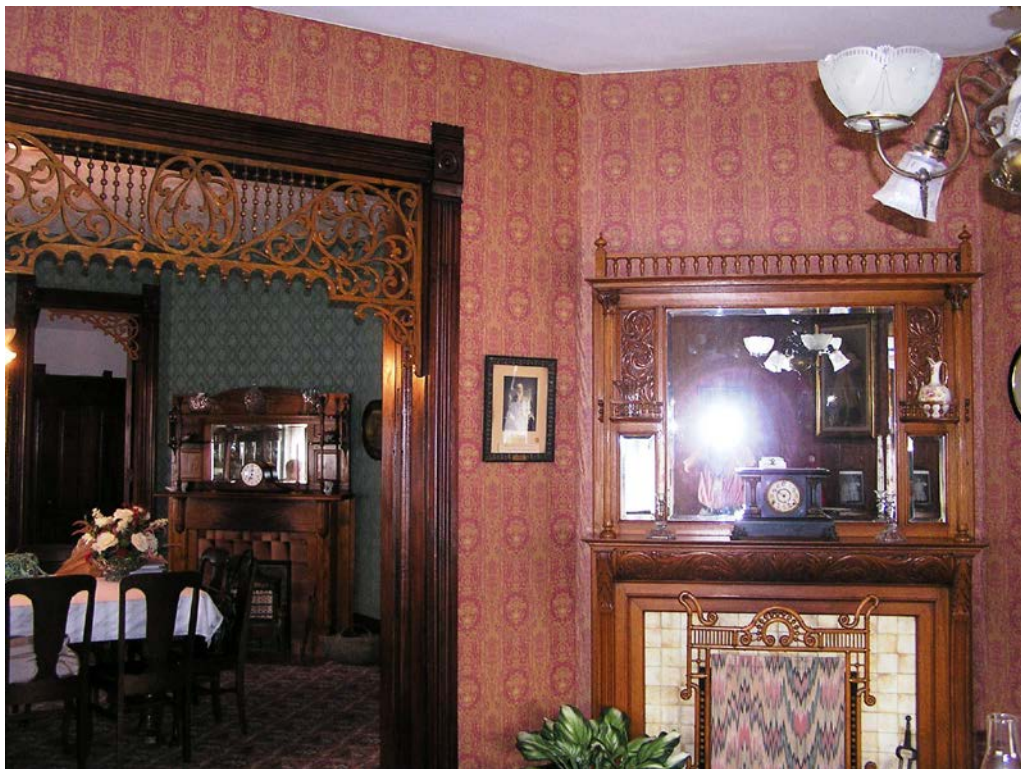
Cragun House, Boone County, IN photo 7

Photo 7 interior, looking N from reception room into library

Most of the first floor connecting doors feature lavish fretwork across the top (see photos 7,8,9,10), which seems somewhat inconsistent with the rest of the house. When the Boone County Historical Society acquired the house, they found this trim in the attic and installed it. The trim fit perfectly, which may suggest it was indeed original. The floors are largely covered with carpeting, some wall-to-wall, some leaving space around the edges to expose the parquet patterns on the perimeters of the rooms (photo 11).
